# Georadar – Ground Penetrating Radar

Damir Varevac

SVEUČILIŠTE  
JOSIPA JURJA STROSSMAYERA  
U OSIJEKU

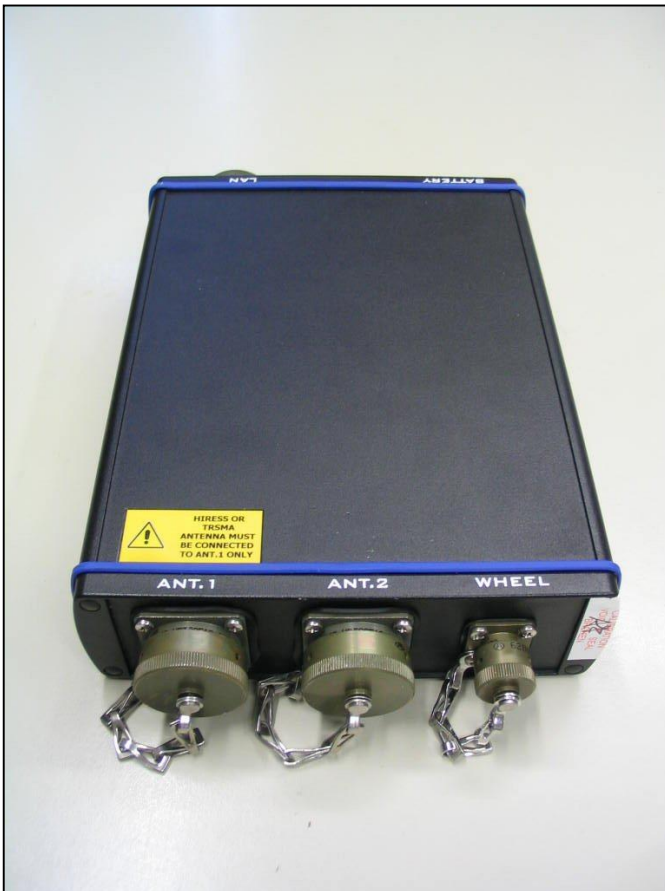
### Control unit

- Generation of transmitting and receiving signals
- A/D conversion of the signals
- Data storage and visualization

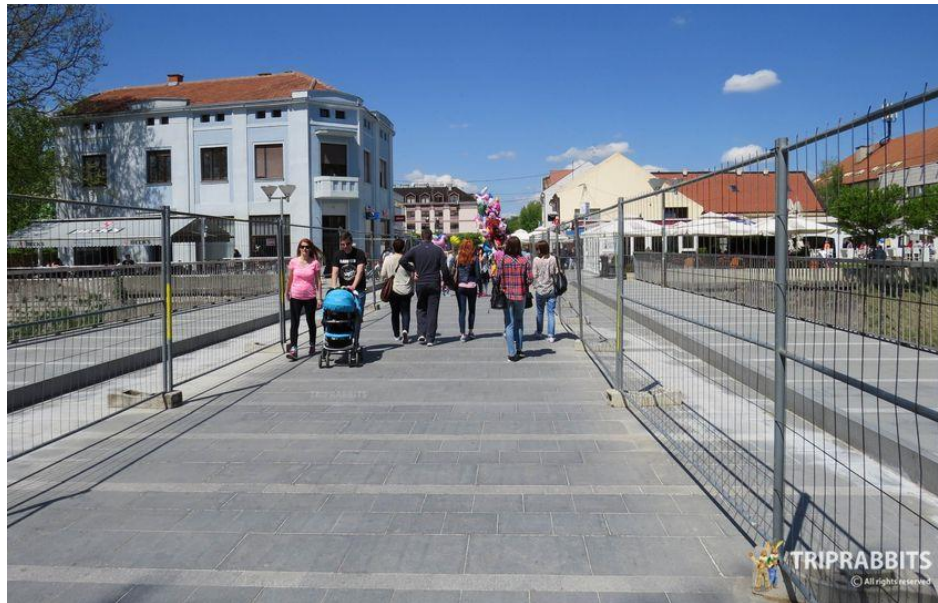
The Remembrance Day and the Procession were very close and closing the bridge down was not an option, as a first measure we decided to limit the number of people crossing over, using the fences.

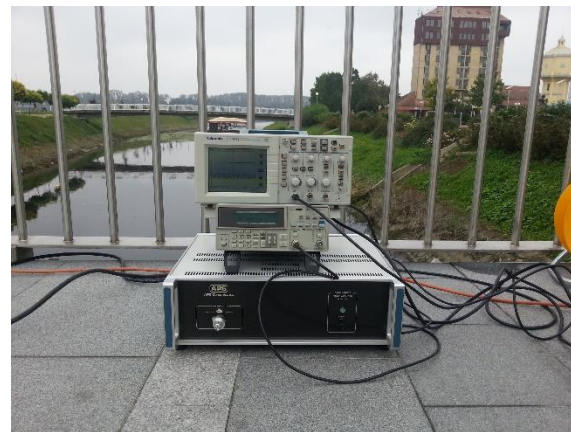
Data aquisition unit
